**DEPARTMENT OF TRANSPORTATION**

Contract #: 04-0120F4Cty: SF/ALA Rte: 80 PM: 13.2/13.9File #: 1.28**WELDING INSPECTION REPORT****Resident Engineer:**Pursell, Gary**Address:** 333 Burma Road**City:** Oakland, CA 94607**Report No:** WIR-012461**Date Inspected:** 05-Mar-2010**Project Name:** SAS Superstructure**OSM Arrival Time:** 700**Prime Contractor:** American Bridge/Fluor Enterprises, a JV**OSM Departure Time:** 1530**Contractor:** American Bridge/Fluor Enterprises, a JV**Location:** Job Site**CWI Name:** See Below**CWI Present:** Yes No**Inspected CWI report:** Yes No N/A**Rod Oven in Use:** Yes No N/A**Electrode to specification:** Yes No N/A**Weld Procedures Followed:** Yes No N/A**Qualified Welders:** Yes No N/A**Verified Joint Fit-up:** Yes No N/A**Approved Drawings:** Yes No N/A**Approved WPS:** Yes No N/A**Delayed / Cancelled:** Yes No N/A**Bridge No:** 34-0006**Component:** Orthotropic Box Girders (OBG)**Summary of Items Observed:**

**Field Splice 1E/2E Face A-1, A-2, A-3**

### Field Splice 1E/2E Face A-4, A-5

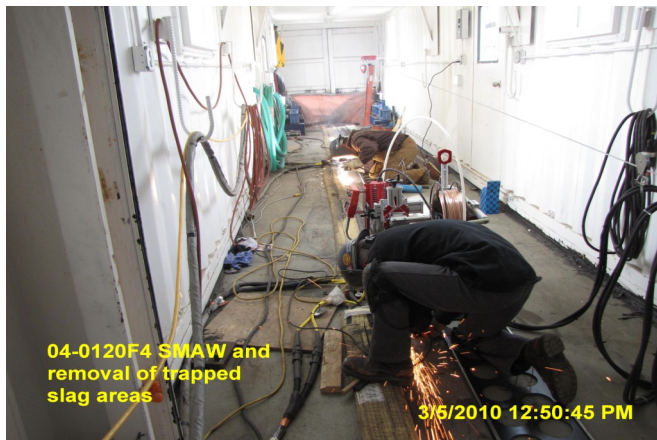
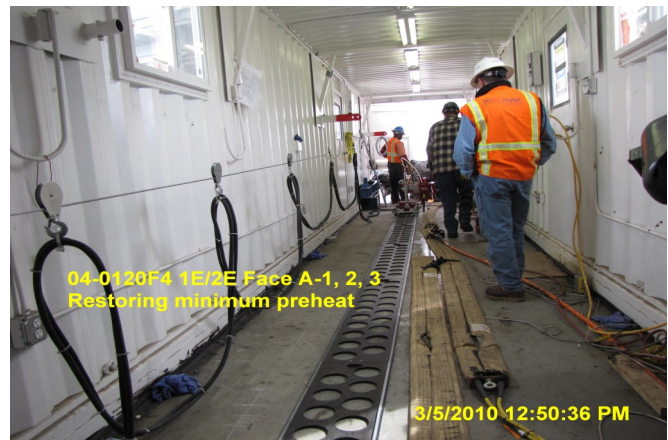
The QA inspector periodically observed the in process Shielded Metal Arc Welding (SMAW) being performed by ABF welding personnel Mitch Sittinger (ID-0315) for field splice welds designated 1E/2E-A4 and A5. The QC inspector Jim Cunningham was noted to be present in order to monitor the progress and ensure the welding was within the established Welding Procedure Specification (WPS) noted as ABF-WPS-D1.5-F1200A. The preheat and interpass temperature was verified by the QA inspector to be greater than 65° Celsius (C) and the parameters were verified to be 125 amps utilizing electrode E7018 H4R. The welder is in the process of filling and leveling the fill passes for these weld locations inside the weld joint due to uneven weld depth from the minor grinding of several location which were identified to have slag trapped in the layers. These areas were previously identified by the QC inspector and ABF welding personnel Jeremy Dolman (ID-5142) is performing the removal of these areas and is also noted to be the welding operator for the SAW. The SMAW and grinding of these locations continued throughout the QA inspectors shift, was not completed and appeared to be progressing in general conformance with the contract documents. See digital photos in the body of this report for general information.
